Manhole Inspection Summary

Manhole # S39II_005MH

Insp Date: **6/8/09 9:04 AM**

Location Address: **1647 AISQUITH ST**

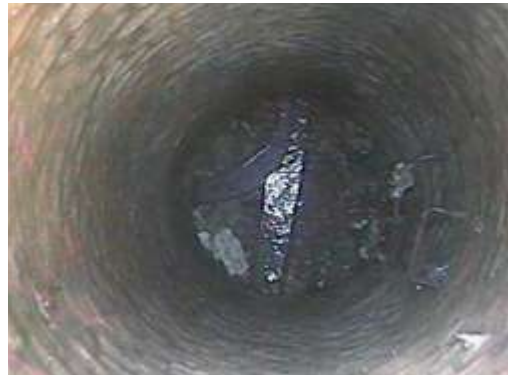
Top View

frame offset, evidence of ASUR on steps

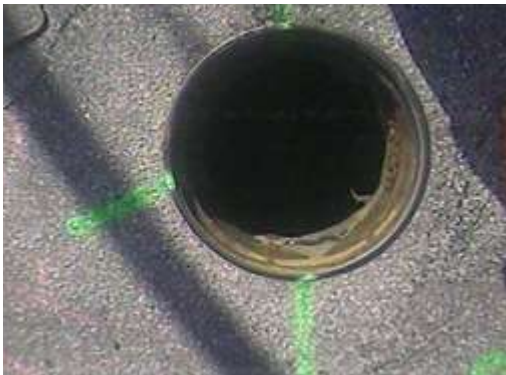
Defect 2

Offset: **1** (in.)

frame offset

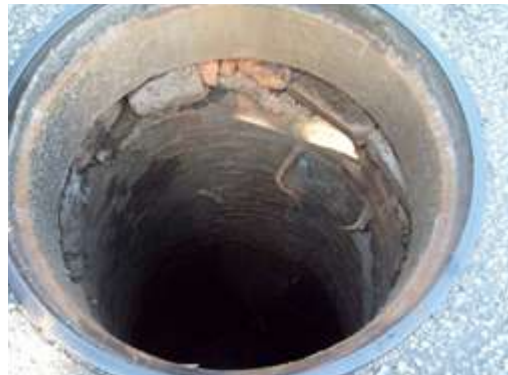
Defect 1

Condition: ☐ Sound ☒ **Cracked** ☐ Root Intrusion ☒ **Loose Brick** ☐ Deteriorated

Count: **9** Missing: **4** ☒ **Corroded**

Loose bricks, cracked chimney, corroded steps
